# TEST REPORT

Brass Cable Gland

M25 \* 1.5

**TEST REPORT****IEC60529****Degrees of protection provided by enclosure(IP code)**

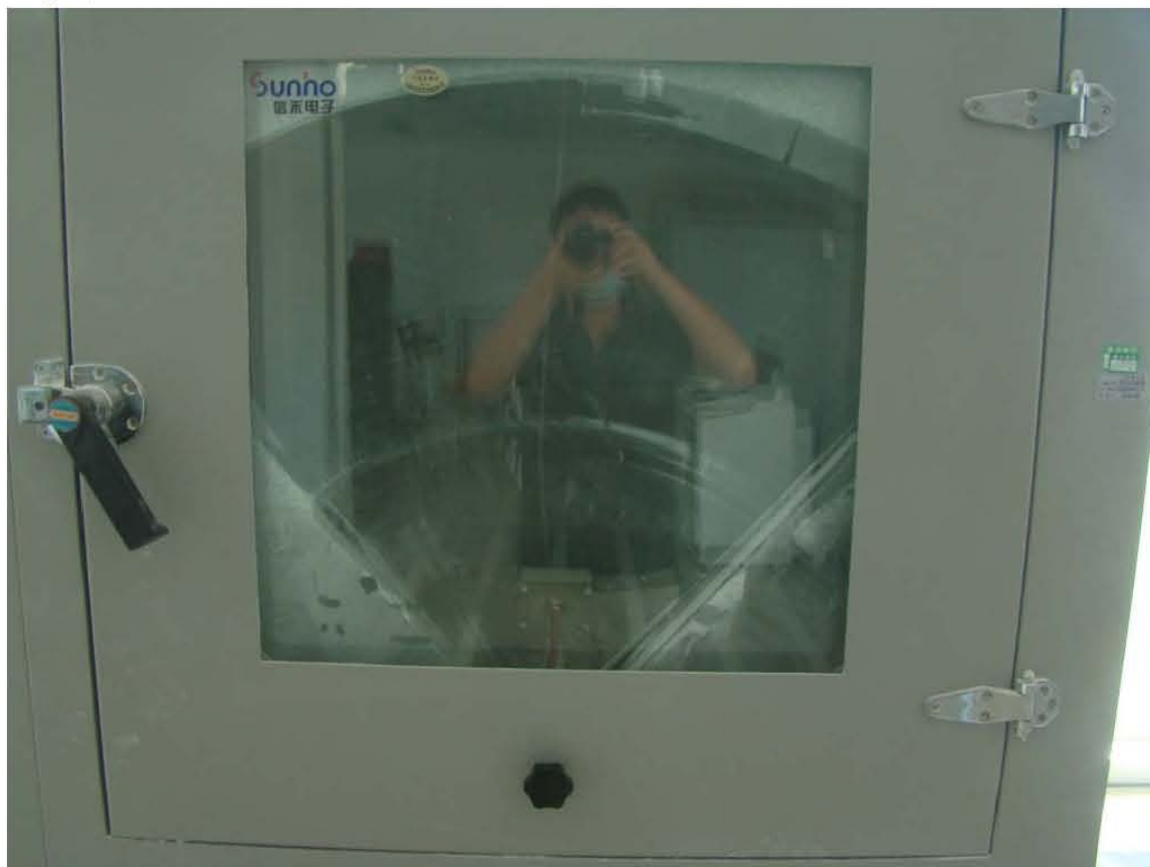
Photograph:

IP6X: The object is freely suspended in the dust chamber, lasted 8 hours with the depression not exceed 2KPa, the pressure inside the enclosure is maintained below the surrounding atmospheric pressure by a vacuum pump.

IP6X: No deposit of dust is observable inside the sample at the end of the test. So the protection is satisfactory.

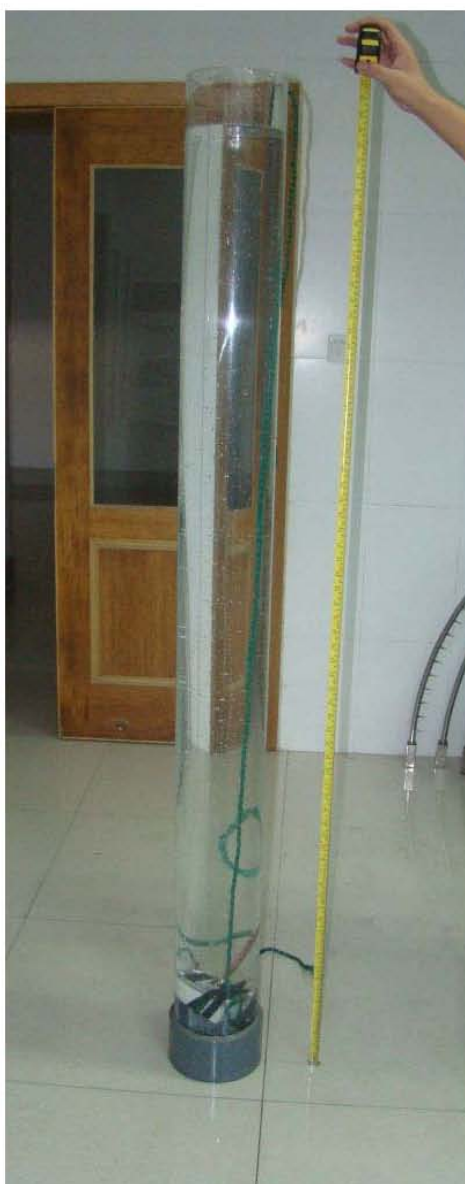
Operating conditions: IPX8: The lowest point of enclosures is located 1.5m below the surface of the water, the duration of the test is 35min; the water temperature does not differ from that of the equipment by more than 5K.

Phenomenon( after the test): IPX8: No water entered.

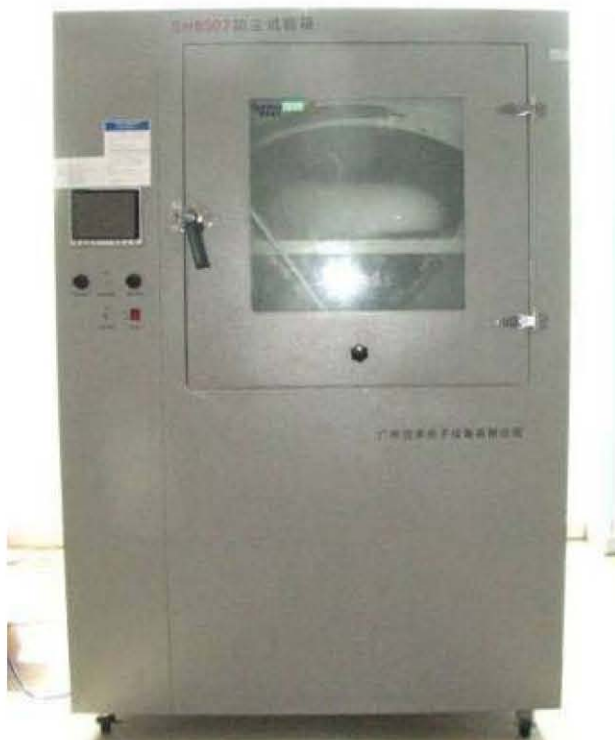
Fig.1 Dust chamber

1. Test equipments: Dust chamber (see Fig. 1), Immersion test device(see Fig. 2),
2. Temperature: 22.5℃ Humidity: 70%RH
