TEST REPORT

NST/GW131423-2-

Cable Gland

AG-25

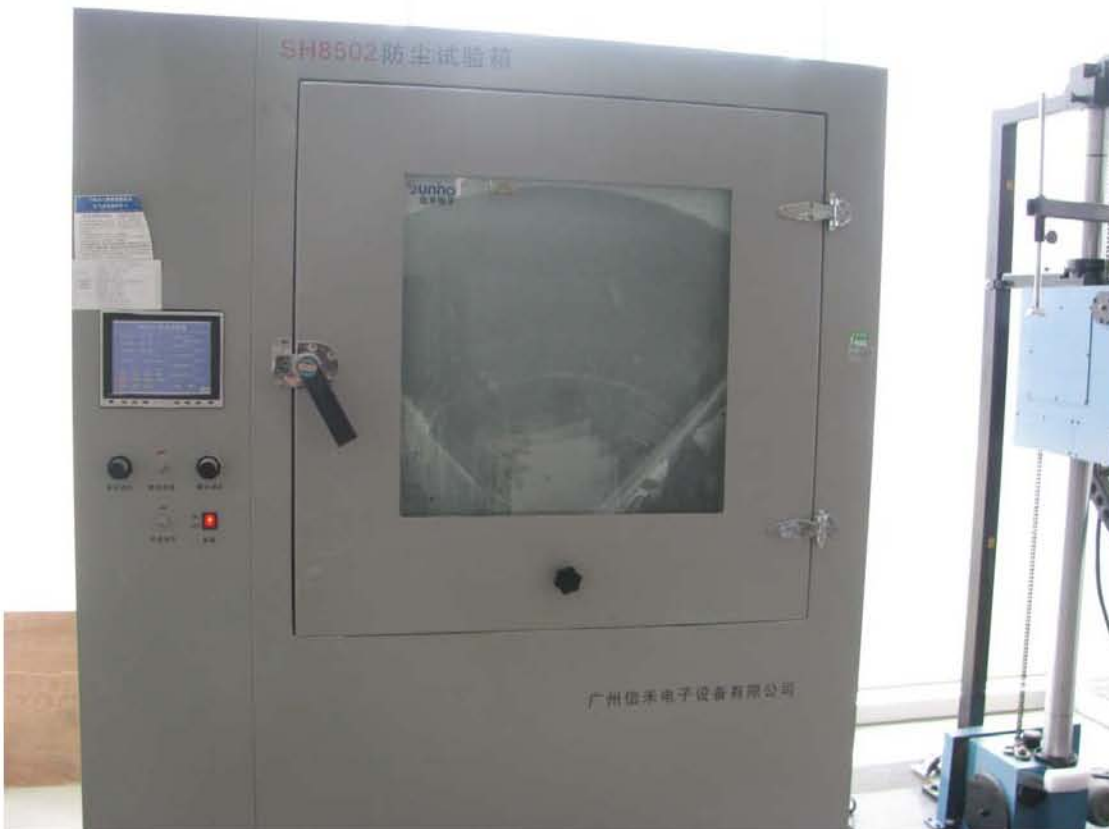
Photograph:

Standard:	IEC60529:2001
IP code:	IP68
Operating conditions:	IP6X: The object is freely suspended in the dust chamber, lasted 8 hours with the depression not exceed 2KPa, the pressure inside the enclosure is maintained below the surrounding atmospheric pressure by a vaccum pump.
Phenomenon(after the test):	IP6X: No deposit of dust is observable inside the sample at the end of the test. So the protection is satisfactory.

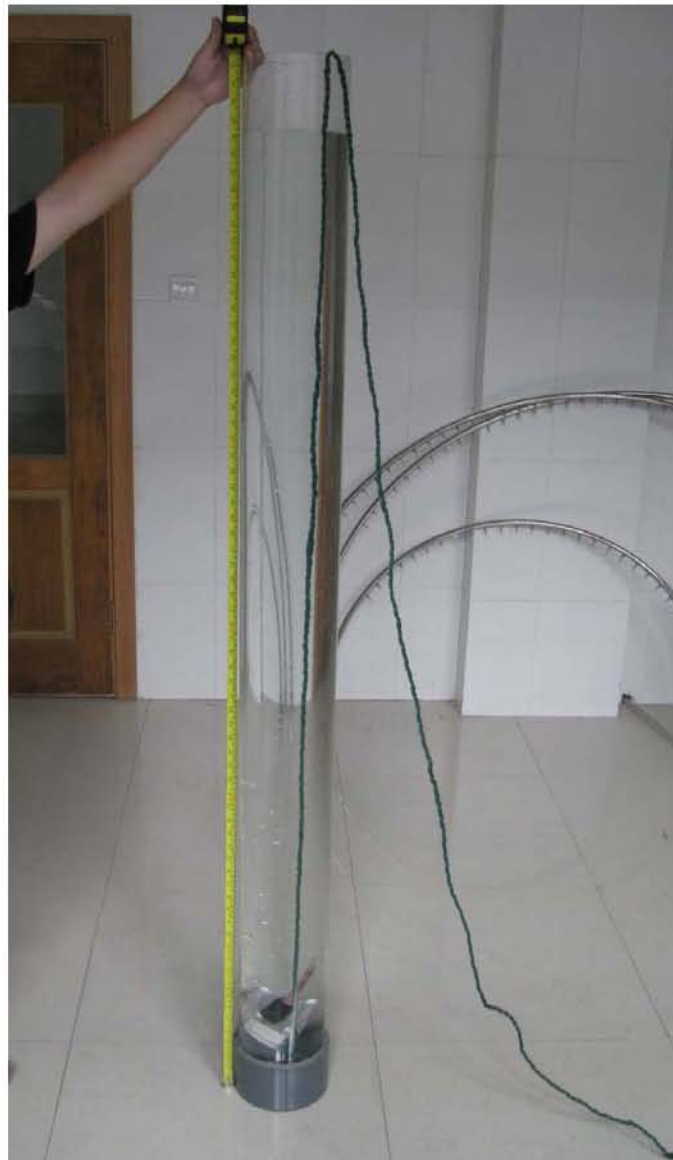
Operating conditions: IPX8: The lowest point of enclosures is located 1.5m below the surface of the water, the duration of the test is 35min; the water temperature does not differ from that of the equipment by more than 5K.

Phenomenon(after the test): IPX8: No water entered.
